# The lost abbey of Syon

### The Importance of Syon Abbey

### The Abbey Church

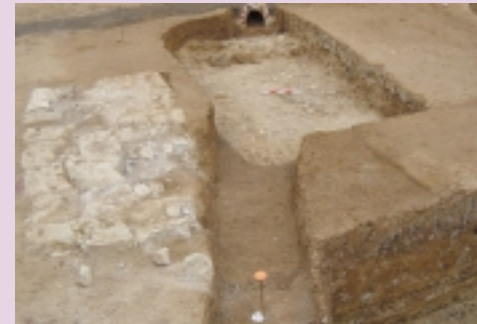
Three rows of massive, closely spaced, masonry pier bases have been found in the excavations. The northern and southern rows may have formed two east-west arcades dividing the church into three aisles. The purpose of the central row is unclear but it may have supported a gallery constructed towards the eastern end of the church.

'Monument' base and pier base with brick culvert from the formal garden

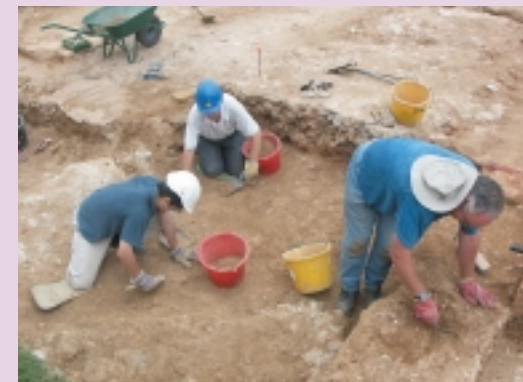
Two rows of brick vaults were constructed at the side of the northern and southern aisles. At least ten pairs in each aisle are likely, suggesting space for a minimum of forty inhumations. Most of the human remains had been removed, probably in landscaping for the gardens, but articulated bones had survived, particularly in the south aisle. Other finds in the graves included more than a dozen pins, two finger rings and a fragment of cloth, probably from a shroud.

Vaults and robbed-out northern church wall

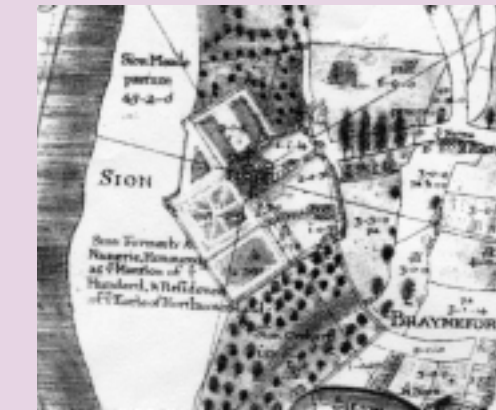
### Moses Glover's Map 1635

This landscape map depicts the quadrangular Syon House of the early 17th century, together with ranges of buildings to the west. An extensive orchard lies to the north and pasture land is shown close to the Thames, east of the house. The map also reveals walkways and beds, incorporated within the extensive formal gardens which border the house, particularly on its eastern side.

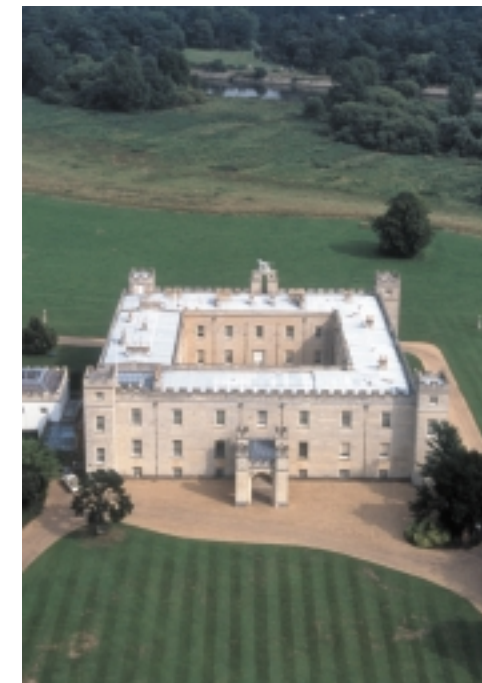
Aerial picture of Syon House, looking east. The excavation is taking place on the lawns and meadows behind the house.

In 2003, geophysical survey and excavation by 'Time Team' revealed some of the wall foundations of the church, immediately east of Syon House. In 2004, Birkbeck, University of London, was invited to undertake annual research and training excavations so that more could be learnt about the monastic complex.

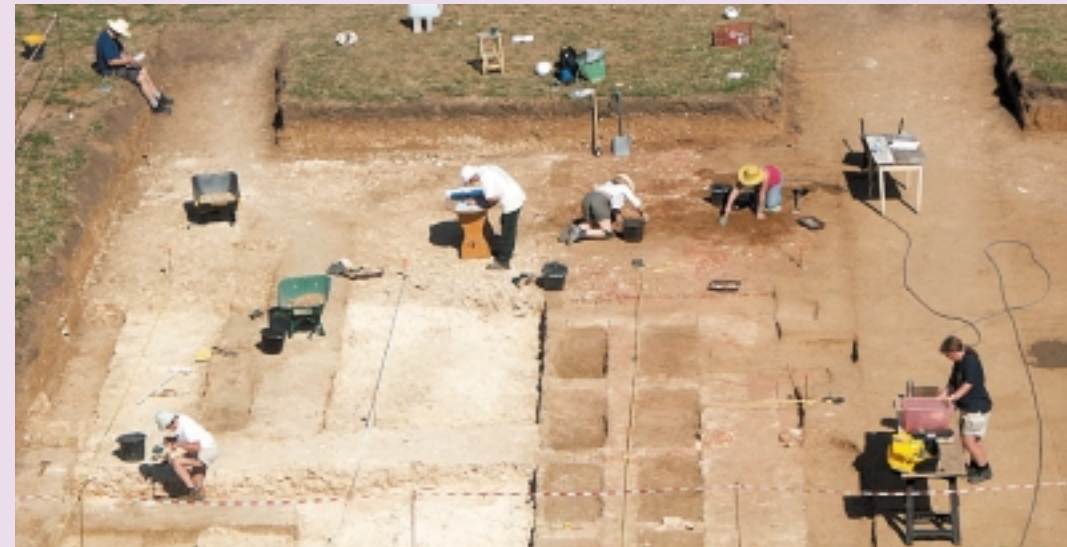
Excavation in progress on the northern wall of the church and the brick-lined burial vaults

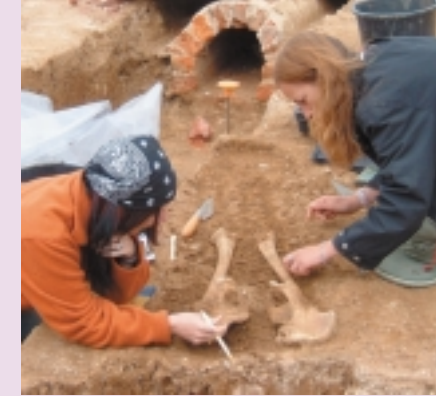
Excavation of a burial

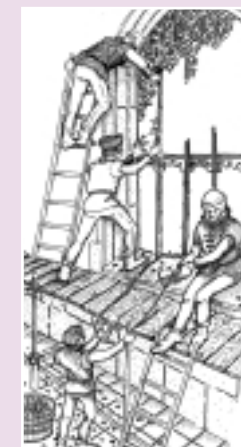
Fragments of window glass and lead

The rubble suggests that much of the fabric of the church was quarried from the North Downs, though stone from Yorkshire and from Caen in Normandy was present. Some moulded stone fragments were probably from windows as were pieces of plain and decorated glass and lead fixings. Green and yellow glazed floor tiles, red roof tiles and iron nails have also been recovered.

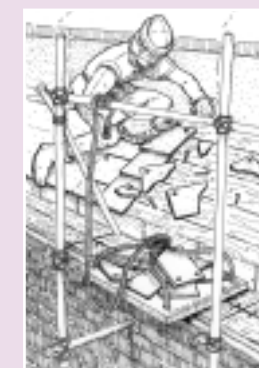
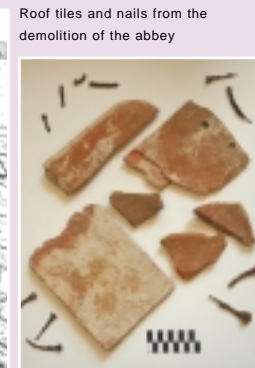
Roof tiles and nails from the demolition of the abbey

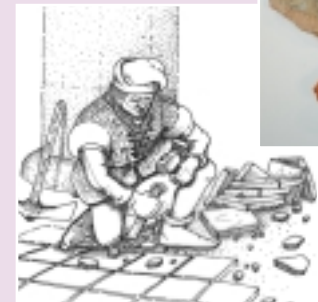
Floor tiles
